**Flood Control Project Maintenance
Levee Inspections**
LMA District Cover Sheet
Spring 2018 Levee Inspection Results

Sutter Maintenance Yard Maintenance Area 0001

Spring 2018 Levee Inspection Results

Waterway			Bank	Unit Miles
Unit No. 01 Sacramento River			Right	16.76
	Spring (March - May)	Summer (June - August)	(September - November) Fall	Winter (December - February)
Unit Maintenance Rating (Fall Only)				
Date of Inspection	3/6/2018 - 3/6/2018			
DWR Inspector	Bob Duffey			
Accompanied By	Bryan Reniff Sutter Maintenance Yard

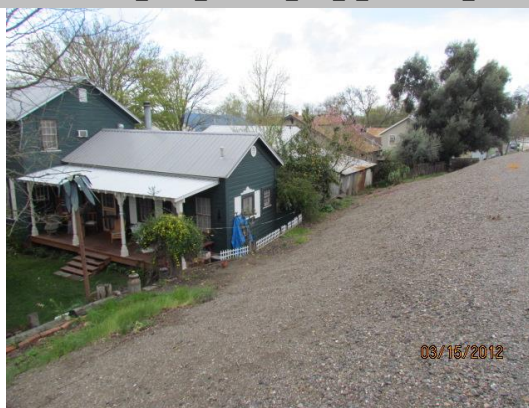
Photo 1 of 1 : SP_2018_MA0001_297_2_20180305_00001.jpg

LM Start	0.04	Rating **	U	Issue No.	2
LM End	0.23	Issue Type +	En	Location *	LS
Category	Earthen Levee			GPS Latitude/Longitude	
				Start	End
Item	Encroachments			39.213988 °	39.215198 °
				-122.001537 °	-122.004775 °
DWR ID	DWR_MA0001_01_s_2012_2				
Comment Code					
BU : Building					
Inspector Comment

View of the building along the landside toe.

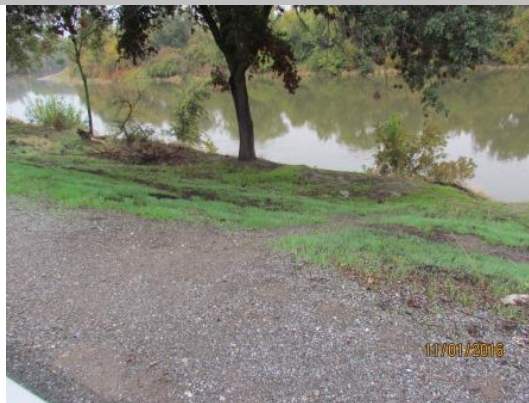
Photo 1 of 1 : SP_2018_MA0001_297_98_20180305_00027.jpg

LM Start	0.38	Rating **	M	Issue No.	98
LM End	0.38	Issue Type +	Ma	Location *	WS
Category	Earthen Levee			GPS Latitude/Longitude	
				Start	End
Item	Slope Stability			39.215878 °	39.215878 °
				-122.007278 °	-122.007278 °
DWR ID	DWR_MA0001_01_f_2016_98				
Comment Code					
S2 : Repair the levee slope damaged by foot traffic and prevent access where possible.					
Inspector Comment

View of the slope instability along the waterside slope.

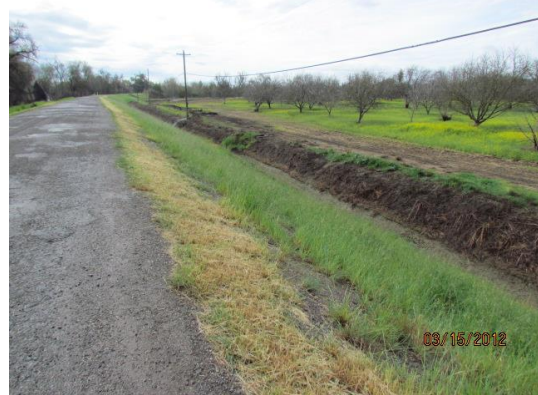
Photo 1 of 1 : SP_2018_MA0001_297_6_20180305_00004.jpg

LM Start	1.20	Rating **	U	Issue No.	6
LM End	1.34	Issue Type +	En	Location *	LS
Category	Earthen Levee			GPS Latitude/Longitude	
				Start	End
Item	Encroachments			39.222119 °	39.224063 °
				-122.015747 °	-122.016080 °
DWR ID	DWR_MA0001_01_s_2012_6				
Comment Code					
DT : Ditch					
Inspector Comment

View of an ag ditch along the landside toe.

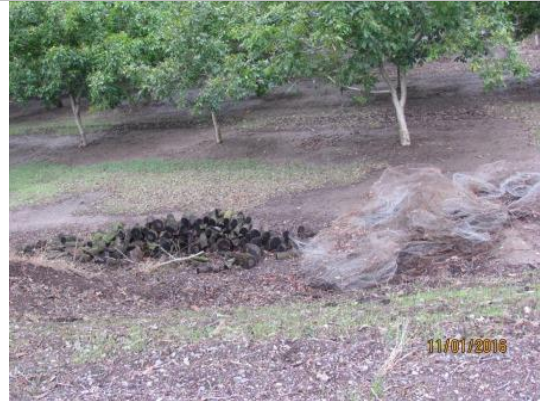
Photo 1 of 1 : SP_2018_MA0001_297_106_20180305_00030.jpg

View of the firewood along the landside toe.

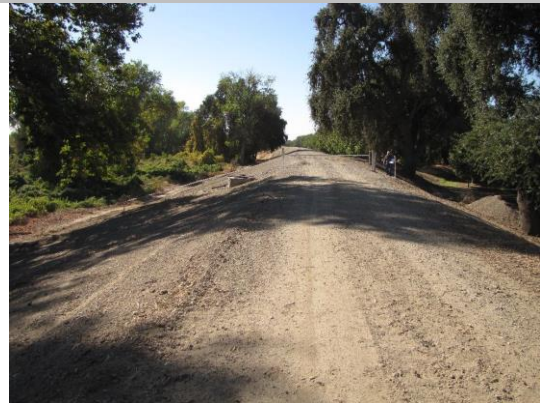
View of levee crown looking downstream at crossing. CMP riser located on WS shoulder.

FS_ID:51854
DS_ID:16429
EP_NO: 9472
Repair Type: Non-Urgent
Crossing Status: Found
UCIP Comments: 5/3/2017 LS inlet partially plugged with soil. Some debris still present inside riser. (DWR Sutter Yard-AFreitag)10/24/2016 Debris still inside of riser.(DWR Sutter Yard-AFreitag)4/25/2016 Pipe still inside of riser and LS end plugged about 50% by soil.4/20/2015 Same as last inspection.6/18/2014 Same as last inspection.12/17/2013 Same as last inspection.7/18/2013 Same as last inspection.10/18/12 Remove debris from riser. Landward inlet is blocked by over 50%. This crossing was listed in the USACE Periodic Inspections as ID# USACE_CESPK_MA1C_2010_p_0128 for sediment build up at inlet (landward side) and debris inside riser.
FIELD_STRUCT_DESC: 54-inch corrugated metal drainage pipe through the levee, approximately 12-15 feet below the crown. Slide gate in corrugated metal pipe (CMP) riser on the waterside (WS) slope. 48-inch CMP at landside (LS) slope. This crossing crosses the levee at an angle. (54-inch pipe [HLM 2.29] authorized under Automatic Board Order (ABO) issued as Permit No. 9472, 1974 - Ballard)) [Additional Reference(s): DWR Levee Log, 1992. USACE Sacramento O&M Manual 137, August 1955, (Station 120+00)].

View of WS looking at slope and channel.

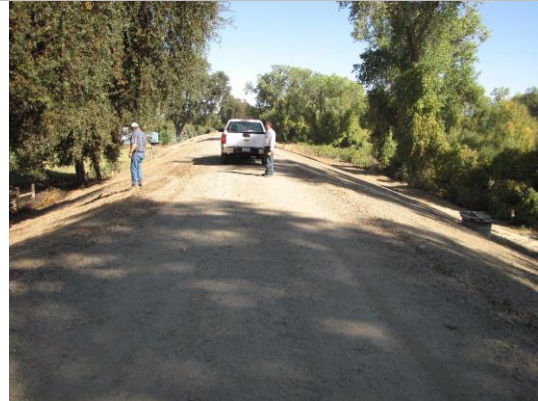
Photo 1 of 3 : UCIP_SP_2018_51855_70085.jpg

Comment Code						
Inspector Comment						
FS_ID:51855 DS_ID:16428 EP_NO: 9467 Repair Type: Non-Urgent Crossing Status: Found UCIP Comments: 5/3/2017 Abandoned- needs to be done so properly. (DWR Sutter Yard- A Freitag)10/24/2016 Abandoned.(DWR Sutter Yard- A Freitag)4/25/2016 Abandoned crossing. Unable to locate any WS and LS pipe ends.4/20/2015 Same as last inspection.6/18/2014 Same as last inspection.12/17/2013 Same as last inspection.7/18/2013 Same as last inspection.10/18/2012 Only riser visible. Debris and sediment blocking gate. Gate inside riser is buried and non-functional. If crossing is abandoned, owner needs to properly abandon. This crossing was listed in the USACE Periodic Inspections as ID# USACE_CESPK_MA1C_2010_p_0132 no culvert through the levee is visible here. FIELD_STRUCT_DESC: *ABANDONED* 24-inch corrugated metal drainage pipe through the levee, approximately 12-15 feet below the crown. Slide gate in CM pipe riser on the waterside (WS) slope. No signs of inlet visible on the landside (LS). (24-inch pipe [HLM 2.31] authorized under Automatic Board Order (ABO) issued as Permit No. 9467, 1974 - Lovell E. Spurgeon) [Additional Reference(s): DWR Levee Log, 1992. USACE Sacramento O&M Manual 137, August 1955, (Station 120+60)]. FS Date: 5/19/2017 1:48:04 PM

Overview of levee crown looking upstream at crossing.

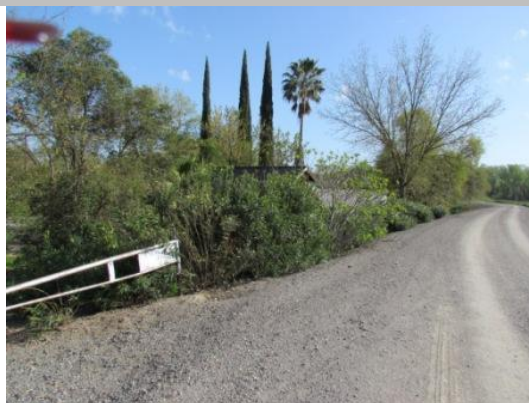
Photo 1 of 1 : SP_2018_MA0001_297_20_20180305_00010.jpg

LM Start	2.53	Rating **	U	Issue No.	20
LM End	2.55	Issue Type +	En	Location *	LS
Category	Earthen Levee			GPS Latitude/Longitude	
				Start	End
Item	Encroachments			39.239750 °	39.239955 °
				-122.010390 °	-122.010090 °
DWR ID	DWR_MA0001_01_s_2012_20				
Comment Code					
BU : Building					
Inspector Comment

View of the house next to the levee.

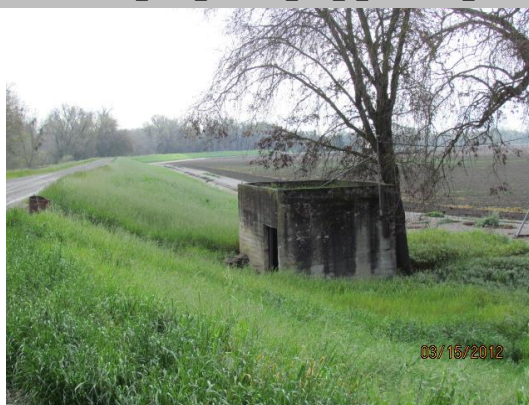
Photo 1 of 1 : SP_2018_MA0001_297_5_20180305_00003.jpg

LM Start	3.05	Rating **	U	Issue No.	5
LM End	3.46	Issue Type +	En	Location *	LS
Category	Earthen Levee			GPS Latitude/Longitude	
				Start	End
Item	Encroachments			39.246813 °	39.252748 °
				-122.008155 °	-122.008320 °
DWR ID	DWR_MA0001_01_s_2012_5				
Comment Code					
DT : Ditch					
Inspector Comment

View of the ag. ditch & concrete building along the landside toe.

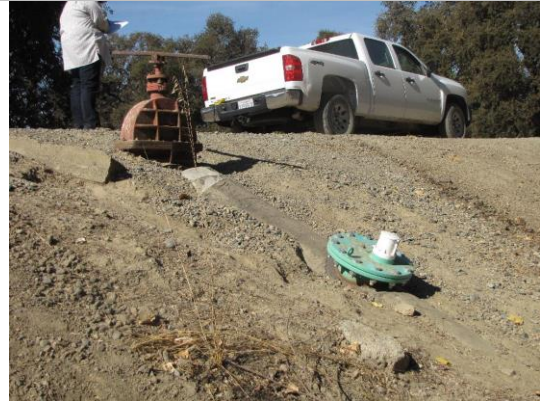
Comment Code						
Inspector Comment						
FS_ID:51860 DS_ID:16436 EP_NO: 4213 Repair Type: Urgent Crossing Status: Found UCIP Comments: 5/3/2017 Sinkhole still present next to concrete structure on LS. (DWR Sutter Yard- AFreitag)10/24/2016 Pump is on WS. Sinkhole still present over pipe alignment next to the concrete building.(DWR Sutter Yard- AFreitag)4/25/2016 No repairs have been made since last inspection. Sink holes are still present above pipe next to concrete building on LS. (DWR Sutter Yard - afreitag)4/20/2015 Sink hole over pipe alignment on LS up against the concrete building. Need to dig up pipe and see if its leaking. (DWR Sutter Yard - afreitag)6/23/2014 Same as last inspection. (DWR Sutter Yard - afreitag)6/18/2014 Same as last inspection. (DWR Sutter Yard - afreitag)12/17/2013 Same as last inspection. (DWR Sutter Yard - afreitag)7/18/2013 Same as last inspection. (DWR Sutter Yard - afreitag)10/19/2012 Recommend adding door to LS concrete structure. Riser located on landward side is damaged. This crossing was listed in the USACE Periodic Inspection as ID# USACE_CESPK_MA1C_2010_p_0194 no issues logged. (DWR UCIP - omagana) FIELD_STRUCT_DESC: 24-inch asphalt coated steel irrigation pipe through the levee, approximately 10 feet below the crown. Gate valve on the waterside (WS) shoulder. 1-1/4 inch conduit through the levee. Siphon breaker on the landside (LS) shoulder. Concrete distribution box and control box located on the LS. Pump, walkway, and gate located on the WS berm. (Permit No. 4213, 1973 - Scott Ranch) [Additional Reference(s): DWR Levee Log, 1992]. FS Date: 5/19/2017 1:57:37 PM

Overview of levee crown looking upstream at crossing.

Gate valve and exposed section of the pipe located on WS.

Siphon breaker and section of exposed pipe located on LS shoulder.

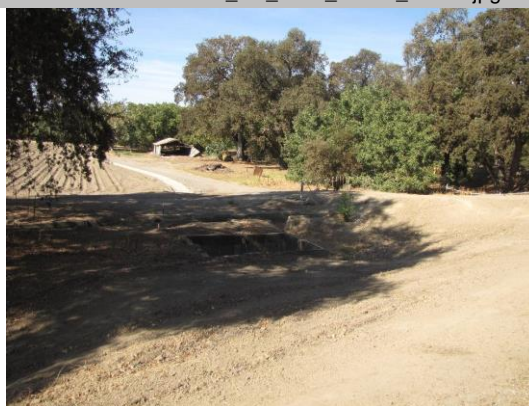
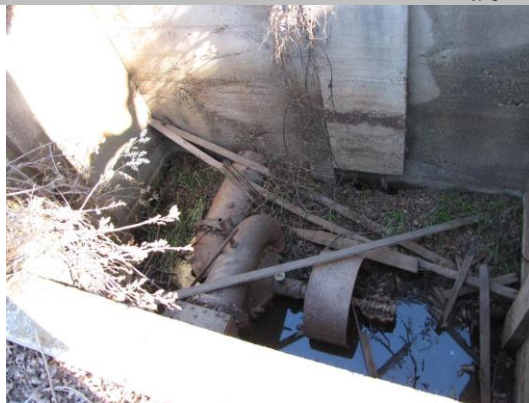
Concrete distribution box located on LS.

Comment Code						
Inspector Comment						
FS_ID:51861 DS_ID:16424 EP_NO: 9490 Repair Type: Non-Urgent Crossing Status: Found UCIP Comments: 5/3/2017 Abandoned- Needs to be done properly. (DWR Sutter Yard- AFreitag)10/24/2016 Abandoned. Needs a cover made for the LS distribution box.(DWR Sutter Yard- AFreitag)4/25/2016 ABANDONED crossing and should be abandoned properly. Concrete distribution box on LS is opened on top and could pose a safety hazard with falling.4/20/2015 Same as last inspection. 6/18/2014 Same as last inspection.12/17/2013 Same as last inspection.7/18/2013 Same as last inspection.10/19/2012 Crossing needs to be properly abandoned. This crossing was listed in the USACE Periodic Inspection as ID# USACE_CESPK_MA1C_2010_p_0194-6 & 7 no issues logged. FIELD_STRUCT_DESC: *ABANDONED* 36-inch corrugated metal irrigation pipe through the levee, approximately 12-15 feet below the crown. Concrete distribution box with pump system located on the landside (LS). Slide gate on the waterside (WS) slope--removed. 18-inch pipe visible on the LS inside 10-foot by 16 foot concrete box. (Automatic Board Order (ABO) issued as Permit No. 9490, 1974 - Charles T & Virginia W. Yerxa) [Additional Reference(s): DWR Levee Log, 1992. USACE Sacramento O&M Manual 137, August 1955 (Station 197+19)] FS Date: 5/19/2017 2:00:07 PM

Debris inside concrete structure located on LS.

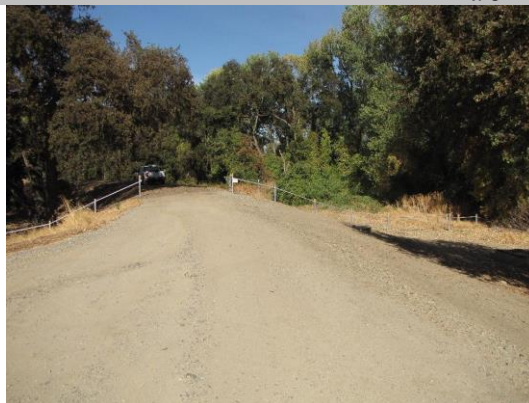
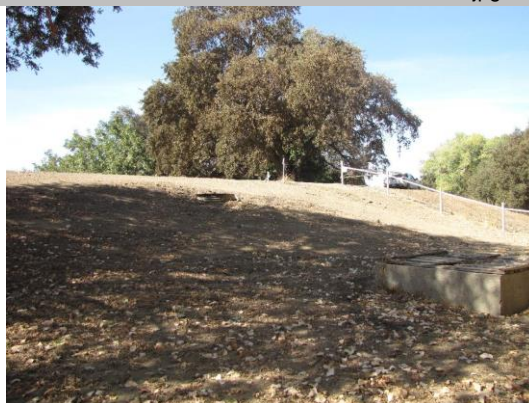
View of crossing looking upstream. Concrete box located on the WS.

View of concrete distribution box and CMP riser located on WS.

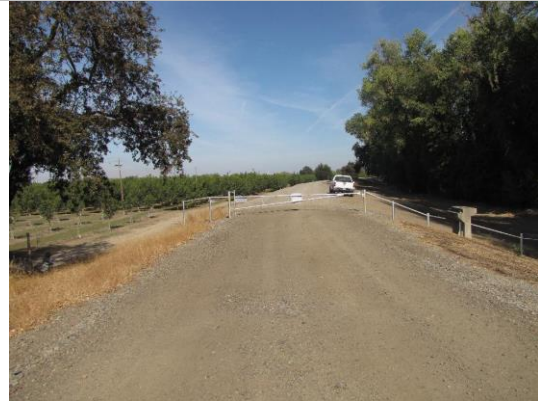
Photo 1 of 3 : UCIP_SP_2018_51864_70137.jpg

Comment Code					
Inspector Comment					
FS_ID:51864 DS_ID:16422 EP_NO: N/A Repair Type: Non-Urgent Crossing Status: Found UCIP Comments: 5/3/2017 Appears abandoned- needs to be done so properly. (DWR Sutter Yard- A Freitag)10/24/2016 Appears to be abandoned.(DWR Sutter Yard- A Freitag)4/25/2016 Appears to be an abandoned crossing. 4/20/2015 Debrs is still blocking gate. Appears to be an abandoned crossing.6/18/2014 Same as last inspection.12/17/2013 Same as last inspection.7/18/2013 Wheel to operate slide gate has been replaced but gate is still blocked by debris.10/19/2012 WS-wheel to operate slide gate missing, walkway has been removed; burrow activity near structure; debris in concrete distribution box WS blocking gate. This crossing was listed in the USACE Periodic Inspection as ID# USACE_CESPK_MA1C_2010_p_0207 the wheel to operate sluice gate missing. FIELD_STRUCT_DESC: *ABANDONED* 24-inch drainage pipe of an unknown material through the levee, unknown depth below the crown. Walkway to slide gate on the waterside (WS) end. Walkway has been removed. Flap gate in concrete distribution box at the landside (LS) toe. [Additional Reference(s): DWR Levee Log, 1992]. FS Date: 5/19/2017 2:05:36 PM

View of levee crown looking upstream at crossing.

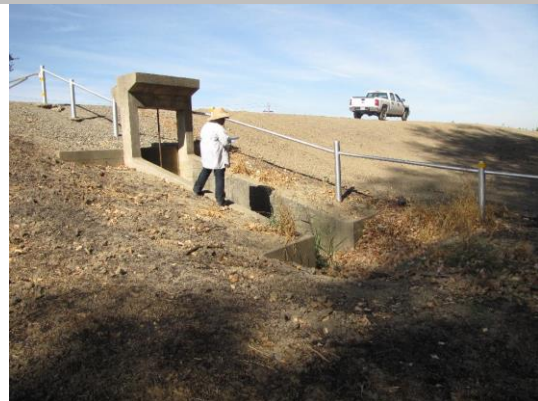
Photo 2 of 3 : UCIP_SP_2018_51864_70139.jpg

View of WS slope with concrete structure.

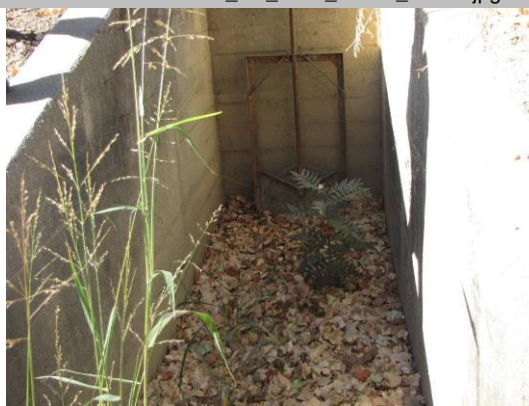
Photo 3 of 3 : UCIP_SP_2018_51864_70138.jpg

Comment Code						
Inspector Comment						
FS_ID:51864 DS_ID:16422 EP_NO: N/A Repair Type: Non-Urgent Crossing Status: Found UCIP Comments: 5/3/2017 Appears abandoned- needs to be done so properly. (DWR Sutter Yard- AFreitag)10/24/2016 Appears to be abandoned.(DWR Sutter Yard- AFreitag)4/25/2016 Appears to be an abandoned crossing. 4/20/2015 Debrs is still blocking gate. Appears to be an abandoned crossing.6/18/2014 Same as last inspection.12/17/2013 Same as last inspection.7/18/2013 Wheel to operate slide gate has been replaced but gate is still blocked by debris.10/19/2012 WS-wheel to operate slide gate missing, walkway has been removed; burrow activity near structure; debris in concrete distribution box WS blocking gate. This crossing was listed in the USACE Periodic Inspection as ID# USACE_CESPK_MA1C_2010_p_0207 the wheel to operate sluice gate missing. FIELD_STRUCT_DESC: *ABANDONED* 24-inch drainage pipe of an unknown material through the levee, unknown depth below the crown. Walkway to slide gate on the waterside (WS) end. Walkway has been removed. Flap gate in concrete distribution box at the landside (LS) toe. [Additional Reference(s): DWR Levee Log, 1992]. FS Date: 5/19/2017 2:05:36 PM

View of slide gate located on WS.

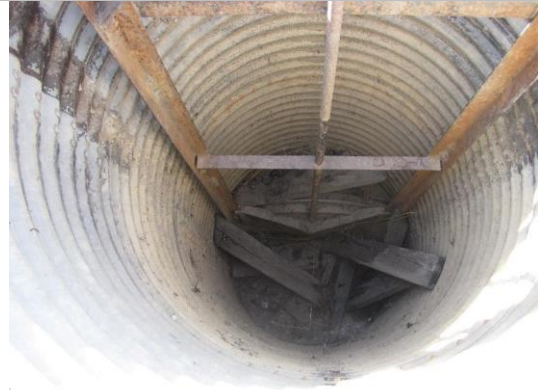
Photo 3 of 3 : UCIP_SP_2018_51865_70146.jpg

Comment Code						
Inspector Comment						
FS_ID:51865 DS_ID:16421 EP_NO: 9475 Repair Type: Non-Urgent Crossing Status: Found UCIP Comments: 5/3/2017 Abandoned- only WS standpipe visible. (DWR Sutter Yard- A Freitag)10/24/2016 Appears to be abandoned.(DWR Sutter Yard- A Freitag)4/25/2016 Abandoned crossing. Only WS standpipe is visible.4/20/2015 Same as last inspection.6/18/2014 Same as last inspection.12/17/2013 Same as last inspection.7/18/2013 Same as last inspection.10/19/2012 Burrow activity; limited visibility of this crossing only on WS riser. This crossing was listed in the USACE Periodic Inspection as ID# USACE_CESPK_MA1C_2010_p_0207 the wheel to operate sluice gate missing. Issue addressed wheel to slide gate has been installed. FIELD_STRUCT_DESC: *ABANDONED* 30-inch corrugated metal irrigation pipe through the levee, 16.1 feet below the crown. Slide gate inside corrugated metal pipe (CMP) riser located on the waterside (WS) end. Line buried on the WS and landside (LS). (Automatic Board Order (ABO) issued as Permit No. 9475, 1974 - Mattie B. Zumwalt Co.) [Additional Reference(s): DWR Levee Log, 1992. USACE Sacramento O&M Manual 137, August 1955, (Station 247+86)]. FS Date: 5/23/2017 9:39:55 AM

WS--Woody debris inside riser blocking gate.

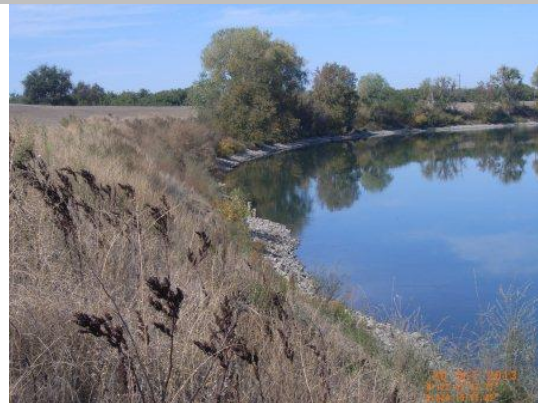
Photo 1 of 1 : SP_2018_MA0001_297_3_20180305_00002.jpg

LM Start	4.86	Rating **	M	Issue No.	3
LM End	5.26	Issue Type +	Ma	Location *	WS
Category	Supplemental			GPS Latitude/Longitude	
				Start	End
Item	2015 USACE Erosion Survey, DRAFT			39.265730 °	39.266315 °
				-122.014925 °	-122.020682 °
DWR ID	DWR_MA0001_01_s_2016_3				
Comment Code					
Inspector Comment					
2009 - Slump in the middle of the section has left a vertical section on the bank. 2010 - Old cobble site unraveling, site extended downstream. 2015: Last observed in 2013. [2015 Site ID: SAC_151-0_R]

USACE 2013 Photo #1

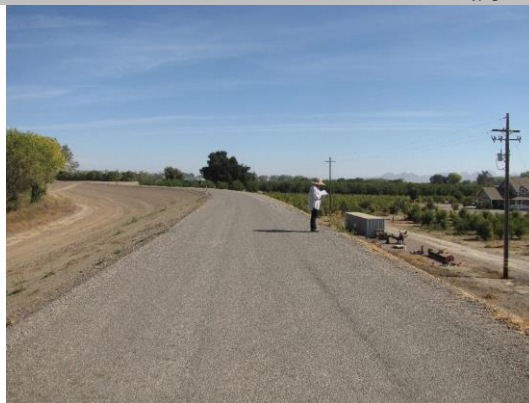
Photo 1 of 3 : UCIP_SP_2018_51868_70150.jpg

Comment Code						
Inspector Comment						
FS_ID:51868 DS_ID:16420 EP_NO: 4903 Repair Type: Non-Urgent Crossing Status: Indicator Found UCIP Comments: 5/3/2017 Appears abandoned- if so needs to be done properly. (DWR Sutter Yard- A Freitag)10/24/2016 appears to be abandoned.(DWR Sutter Yard- A Freitag)4/25/2016 Appears to be an abandoned crossing.4/20/2015 Suspect that pump on LS is a well pump and has nothing to do with this crossing.6/18/2014 Same as last inspection.12/17/2013 Same as last inspection.7/18/2013 Same as last inspection.10/19/2012 Unable to locate siphon breaker, pump on LS; unable to tell if pump system is part of appurtenances. This crossing was listed in the USACE Periodic Inspection as ID# USACE_CESPK_MA1C_2010_p_0233 for utility pole and 8 inch steel riser located on landward toe. FIELD_STRUCT_DESC: 12-inch asphalt coated steel irrigation pipe through the levee, approximately 18-20 feet below the crown. Siphon breaker in 24-inch corrugated metal pipe (CMP) riser on the landside (LS) shoulder--not found. 3-inch electrical conduit through the levee--not found. Utility pole visible on the LS. Well station visible on the LS. No appurtenances visible on the waterside (WS). (Permit No. 4903, 4903-A, 1966 - Mattie B. Zumwalt Company, Inc.) [Additional Reference(s): DWR Levee Log, 1992]. FS Date: 5/23/2017 9:41:40 AM

View of levee crown looking downstream at crossing.

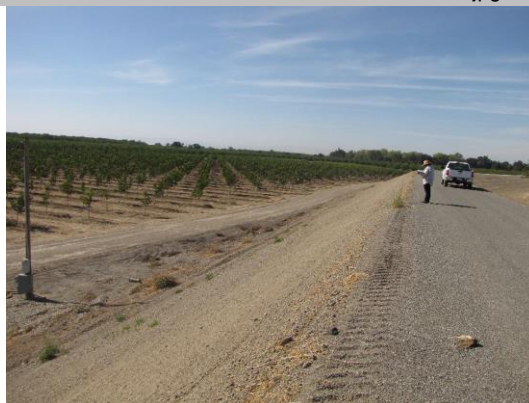
Photo 2 of 3 : UCIP_SP_2018_51868_70149.jpg

View of levee crown looking upstream at crossing.

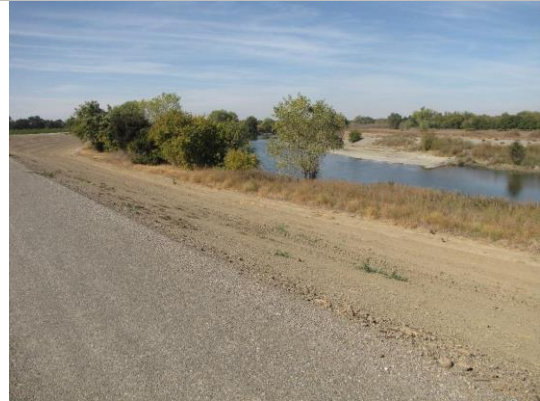
Photo 3 of 3 : UCIP_SP_2018_51868_70148.jpg

Comment Code					
Inspector Comment					
<p>FS_ID:51868 DS_ID:16420 EP_NO: 4903 Repair Type: Non-Urgent Crossing Status: Indicator Found UCIP Comments: 5/3/2017 Appears abandoned- if so needs to be done properly. (DWR Sutter Yard- AFreitag)10/24/2016 appears to be abandoned.(DWR Sutter Yard- AFreitag)4/25/2016 Appears to be an abandoned crossing.4/20/2015 Suspect that pump on LS is a well pump and has nothing to do with this crossing.6/18/2014 Same as last inspection.12/17/2013 Same as last inspection.7/18/2013 Same as last inspection.10/19/2012 Unable to locate siphon breaker, pump on LS; unable to tell if pump system is part of appurtenances. This crossing was listed in the USACE Periodic Inspection as ID# USACE_CESPK_MA1C_2010_p_0233 for utility pole and 8 inch steel riser located on landward toe. FIELD_STRUCT_DESC: 12-inch asphalt coated steel irrigation pipe through the levee, approximately 18-20 feet below the crown. Siphon breaker in 24-inch corrugated metal pipe (CMP) riser on the landside (LS) shoulder--not found. 3-inch electrical conduit through the levee--not found. Utility pole visible on the LS. Well station visible on the LS. No appurtenances visible on the waterside (WS). (Permit No. 4903, 4903-A, 1966 - Mattie B. Zumwalt Company, Inc.) [Additional Reference(s): DWR Levee Log, 1992]. FS Date: 5/23/2017 9:41:40 AM</p>

View of WS-no visible appurtenances associated with structure.

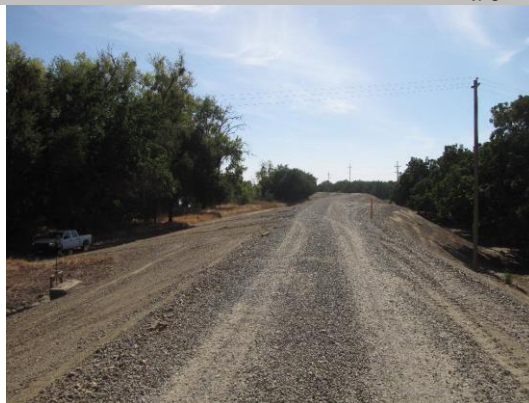
Photo 1 of 3 : UCIP_SP_2018_51869_70154.jpg

Comment Code						
Inspector Comment						
FS_ID:51869 DS_ID:16419 EP_NO: 9476 Repair Type: Non-Urgent Crossing Status: Found UCIP Comments: 5/3/2017 Culvert has sediment build up in it- needs to be cleaned out. (DWR Sutter Yard- AFreitag)10/24/2016 LS outlets becoming over grown with vegetation in the ditch.(DWR Sutter Yard- AFreitag)4/25/2016 WS entry still blocked and wingwalls still cracked.4/20/2015 WS entry still blocked and wingwalls still cracked.6/18/2014 Same as last inspection.12/17/2013 Same as last inspection.7/18/2013 Same as last inspection.10/19/2012 blocked, no entry on WS. This crossing was listed in the USACE Periodic Inspection as ID# USACE_CESPK_MA1C_2010_p_0247 for u/s and d/s wing wall shows some cracking and tilting. FIELD_STRUCT_DESC: 1 of 2: 36-inch corrugated metal irrigation pipe and concrete box culvert through the levee at an unknown depth below the crown. Concrete headwall visible on the landside (LS) toe. (Automatic Board Order (ABO) issued as Permit No. 9476, 1974 - Ohliger) [Additional Reference(s): DWR Levee Log, 1992]. FS Date: 5/23/2017 9:51:10 AM

Overview of levee crown looking downstream at crossing.

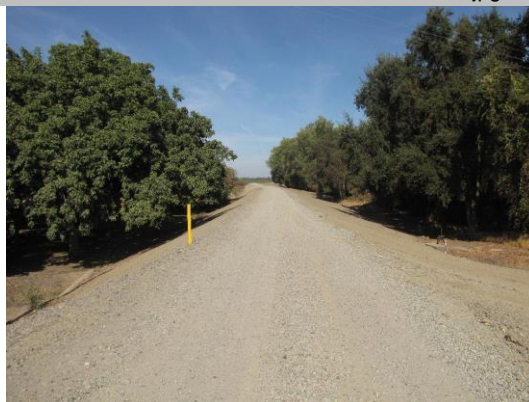
Photo 2 of 3 : UCIP_SP_2018_51869_70152.jpg

View of crossing looking upstream at crossing.

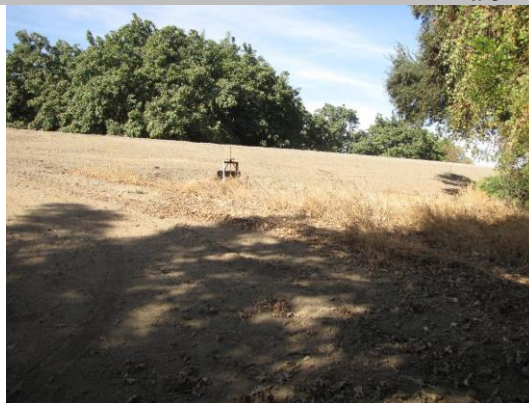
Photo 3 of 3 : UCIP_SP_2018_51869_70156.jpg

Comment Code						
Inspector Comment						
FS_ID:51869 DS_ID:16419 EP_NO: 9476 Repair Type: Non-Urgent Crossing Status: Found UCIP Comments: 5/3/2017 Culvert has sediment build up in it- needs to be cleaned out. (DWR Sutter Yard- AFreitag)10/24/2016 LS outlets becoming over grown with vegetation in the ditch.(DWR Sutter Yard- AFreitag)4/25/2016 WS entry still blocked and wingwalls still cracked.4/20/2015 WS entry still blocked and wingwalls still cracked.6/18/2014 Same as last inspection.12/17/2013 Same as last inspection.7/18/2013 Same as last inspection.10/19/2012 blocked, no entry on WS. This crossing was listed in the USACE Periodic Inspection as ID# USACE_CESPK_MA1C_2010_p_0247 for u/s and d/s wing wall shows some cracking and tilting. FIELD_STRUCT_DESC: 1 of 2: 36-inch corrugated metal irrigation pipe and concrete box culvert through the levee at an unknown depth below the crown. Concrete headwall visible on the landside (LS) toe. (Automatic Board Order (ABO) issued as Permit No. 9476, 1974 - Ohliger) [Additional Reference(s): DWR Levee Log, 1992]. FS Date: 5/23/2017 9:51:10 AM

View of WS slope and access road. Slide gate is second crossing at this location.

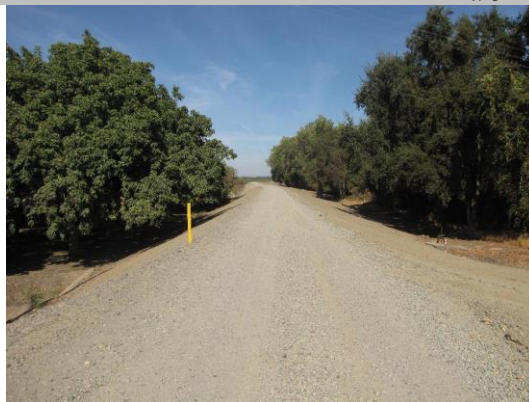
Photo 2 of 3 : UCIP_SP_2018_51870_70161.jpg

FS_ID:51870
DS_ID:17569
EP_NO: 9476
Repair Type: Non-Urgent
Crossing Status: Found
UCIP Comments: 5/3/2107 Culvert has sediment build up in it- needs to be cleaned out. (DWR Sutter Yard- AFreitag)10/24/2016 LS outlets becoming overgrown with vegetation in the dtch.(DWR Sutter Yard- AFreitag)4/25/2016 WS entry still blocked and wingwalls still cracked.4/20/2015 WS entry still blocked and wingwalls still cracked.6/18/2014 Same as last inspection.12/17/2013 Same as last inspection.7/18/2013 Same as last inspection.10/19/2012 blocked, no entry on WS. This crossing was listed in the USACE Periodic Inspection as ID# USACE_CESPK_MA1C_2010_p_0247 for u/s and d/s wing wall shows some cracking and tilting.
FIELD_STRUCT_DESC: 2 of 2: 36-inch corrugated metal irrigation pipe (15 feet long) and concrete box culvert through the levee at an unknown depth below the crown. Slide gate located on the waterside (WS). Concrete headwall visible on the landside (LS) toe. (Automatic Board Order (ABO) issued as Permit No. 9476-1974, Howard C. & Nadine M. Ohliger) [Additional Reference(s): DWR Levee Log, 1992].

View of levee crown looking upstream at crossing.

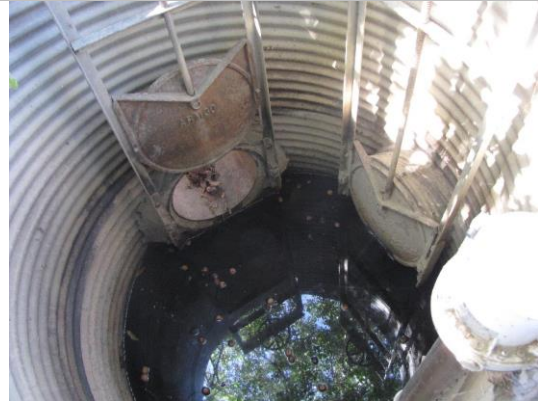
Photo 3 of 3 : UCIP_SP_2018_51872_70171.jpg

Comment Code						
Inspector Comment						
FS_ID:51872 DS_ID:16418 EP_NO: 6263 Repair Type: Non-Urgent Crossing Status: Found UCIP Comments: 5/3/2017 Crossing appears to be in good condition. (DWR Sutter Yard- AFreitag)10/24/2016 Appears to be in good condition.(DWR Sutter Yard- AFreitag)4/25/2016 Pressure gauge and valve were added to pipe near the siphon breaker on LS shoulder.4/20/2015 Modifications are being made to pipe near the LS shoulder. Not sure what all exactly is being done.6/23/2014 Same as last inspection. 12/17/2013 Same as last inspection.7/18/2013 Debris cleared from in front of LS standpipe.10/19/2012 Remove debris from landward side see photo 2. This crossing was listed in the USACE Periodic Inspection as ID# USACE_CESPK_MA1C_2010_p_0249 however, unable to determine why crossing was marked "U". FIELD_STRUCT_DESC: 18-inch asphalt coated steel irrigation pipe through the levee, 2 feet below the crown. Siphon breaker on the landside (LS) shoulder. Corrugated metal pipe (CMP) riser located on the LS connects with concrete V-ditch. Dual slant pumps and gate valves on the bank approximately 215 feet from waterside (WS) toe. Pump feeds into single 18-inch steel pipe. 2-inch electrical conduit buried in the same trench as the irrigation pipe. (Permit No. 6263, 1968 - C. Tuttle) [Additional Reference(s): DWR Levee Log, 1992]. FS Date: 5/23/2017 10:05:22 AM

Photo 1 of 2 inside view of CMP riser located on LS toe.

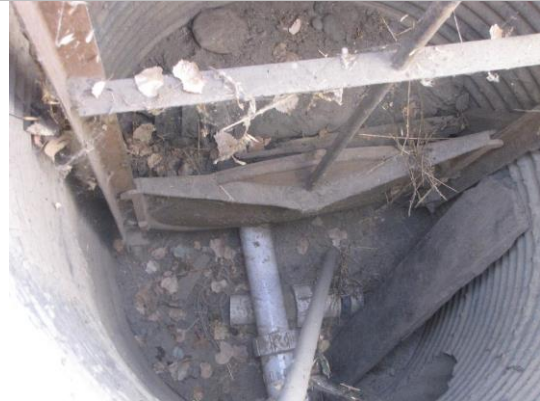
Photo 3 of 3 : UCIP_SP_2018_51873_70175.jpg

FS_ID:51873
DS_ID:16446
EP_NO: N/A
Repair Type: Urgent
Crossing Status: Found
UCIP Comments: 5/3/2017 Pipe leaked during the Jan/Feb 2017 high water event. Sand bags were placed at both the LS and WS outlets as well as down inside the standpipe to slow the water flow. The 5inch pvc was cut away but the slide gate could still not close fully. Suspect sediment build up was in the bottom of the stand pipe was blocking the gate. Inside of pipe should be cleaned out. (DWR Sutter Yard- AFreitag)10/24/2016 Pvc was back running through the crossing and blocking the screwgate. photo attached(DWR Sutter Yard- AFreitag)9/28/2016 Crossing has been downgraded from Urgent to Non-Urgent 5-inch PVC pipe was cut to allow the slide gate to close. Need to contact owner to remove unauthorized pipe to comply with Title 23. (DWR UCIP - omagana)4/25/2016 5 inch pvc pipe running through crossing has been cut out to allow the slide gate to close. (DWR Sutter Yard - afreitag)4/20/2015 5inch pvc is still present blocking slide gate from closing. WS end of pipe has been exposed so there is no way to stop water from flowing through pipe during highwater times. (DWR Sutter Yard - afreitag)6/23/2014 Same as last inspection. There is no way to stop water from flowing through pipe during high water times. (DWR Sutter Yard - afreitag)12/17/2013 Same as last inspection. (DWR Sutter Yard - afreitag)7/18/2013 Same as last inspection. (DWR Sutter Yard - afreitag)10/19/2012 Unauthorized 5 inch PVC pipe running through 36 inch crossing. 5 inch PVC crossing prevents slide gate from closing during high water. Debris and sediment inside riser. This crossing was listed in the USACE Periodic Inspection as ID# USACE_CESPK_MA1C_2010_p_0258 for 5 inch PVC pipe running through culvert. (DWR UCIP - omagana) FIELD_STRUCT_DESC: 36-inch steel (not corrugated metal, as referenced in O&M manual) drainage pipe through the levee, approximately 14-16 feet below levee crown. Slide gate in corrugated metal pipe (CMP) riser on the waterside (WS) slope. Pipe also visible on the landside (LS). [Additional Reference(s): DWR Levee Log, 1992. USACE Sacramento O&M Manual 137, August 1955, (Station 331+31)]. FS Date: 5/23/2017 10:07:43 AM

WS-Inside view of CMP riser, 5-inch pipe through 36-inch drainage pipe.

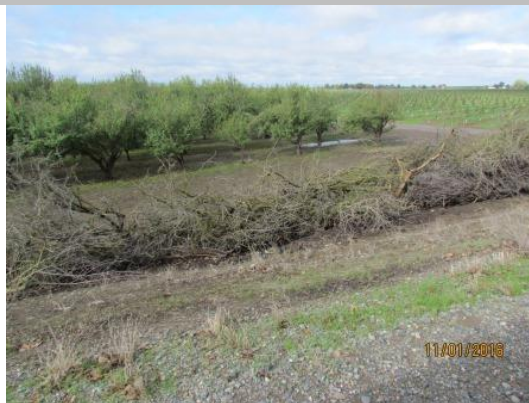
Photo 1 of 1 : SP_2018_MA0001_297_115_20180305_00035.jpg

LM Start	6.38	Rating **	M	Issue No.	115
LM End	6.38	Issue Type +	En	Location *	LS
Category	Earthen Levee			GPS Latitude/Longitude	
				Start	End
Item	Encroachments			39.281425 °	39.281425 °
				-122.022000 °	-122.022000 °
DWR ID	DWR_MA0001_01_f_2016_115				
Comment Code					
PR : Prunings					
Inspector Comment					
Remove prunings from the landside toe.

View of the prunings along the landside toe.

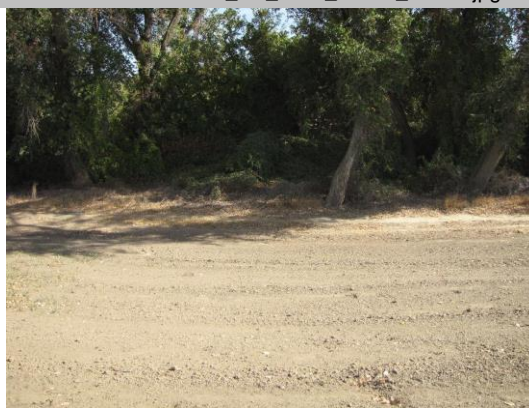
Photo 1 of 3 : UCIP_SP_2018_51874_70181.jpg

LM Start	6.40	Rating **	M	Issue No.	657	
LM End	6.40	Issue Type +	Ma	Location *		
Category	Supplemental			GPS Latitude/Longitude		
				Start	End	
Item	DWR UCIP LMA Responsibility			39.281721 °	39.281721 °	
				-122.021894 °	-122.021894 °	
DWR ID

Comment Code						
Inspector Comment						
FS_ID:51874 DS_ID:16425 EP_NO: N/A Repair Type: Non-Urgent Crossing Status: Found UCIP Comments: 5/3/2017 Abandoned- needs to be done properly. (DWR Sutter Yard- A Freitag)10/24/2016 Abandoned(DWR Sutter Yard- A Freitag)4/25/2016 Abandoned crossing.4/20/2015 Same as last inspection.6/23/2014 Same as last inspection.12/17/2013 Same as last inspection.7/18/2013 Same as last inspection.10/19/2012 Need to be properly abandoned concrete structure; plate covers concrete box; Concrete headwall damaged. This crossing was listed in the USACE Periodic Inspection as ID# USACE_CESPK_MA1C_2010_p_0262 for damage to concrete structure (vertical 2 inch wide cracks and spalling visible). FIELD_STRUCT_DESC: *ABANDONED* 72-inch corrugated metal (precast concrete) drainage pipe through the levee at an unknown depth below the crown. Structure is blocked on the waterside (WS) end with 3-foot concrete plug installed in 1980. Slide gate in concrete well on the landside (LS) shoulder. Concrete headwall at both toes. WS headwall not found. [Additional Reference(s): DWR Levee Log, 1992. USACE Sacramento O&M Manual 137, August 1955, (Station 339+74)]. FS Date: 5/23/2017 10:13:24 AM

View of WS no structure features visible.

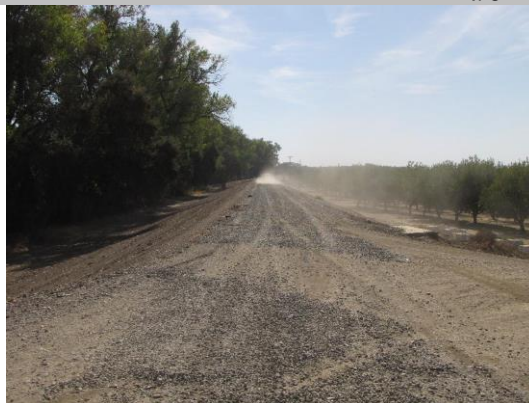
Photo 2 of 3 : UCIP_SP_2018_51874_70180.jpg

LM Start	6.40	Rating **	M	Issue No.	657 (cont)
LM End	6.40	Issue Type +	Ma	Location *

Overview of levee crown looking downstream at crossing.

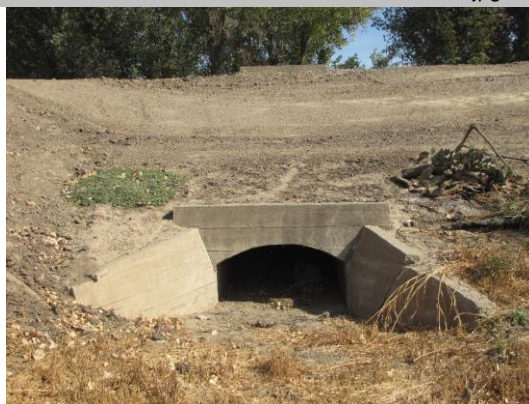
Photo 3 of 3 : UCIP_SP_2018_51874_70179.jpg

View of structure located in LS.

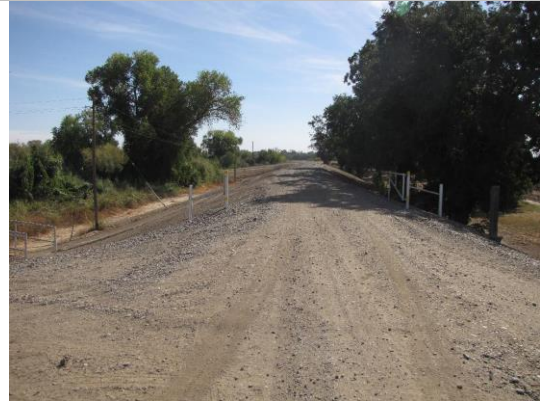
Photo 1 of 3 : UCIP_SP_2018_51875_70188.jpg

Comment Code						
Inspector Comment						
FS_ID:51875 DS_ID:16427 EP_NO: 9482 Repair Type: Non-Urgent Crossing Status: Found UCIP Comments: 5/3/2017 Abandoned- Needs to be done properly. (DWR Sutter Yard- A Freitag)10/24/2016 Abandoned.(DWR Sutter Yard- A Freitag)4/25/2016 Abandoned pipe. Needs to be properly plugged if it never gets used.4/20/2015 Same as last inspection. Structure is still buried.6/23/2014 Same as last inspection.12/17/2013 Same as last inspection.7/18/2013 Same as last inspection.10/19/2012 Structure is buried and non-operational. This crossing was listed in the USACE Periodic Inspection as ID# USACE_CESPK_MA1C_2010_p_0288 for sluice gate closed and backfilled on WS and full of sediment with wingwall cracked on LS. FIELD_STRUCT_DESC: *ABANDONED* 1 of 2: 36-inch reinforced concrete irrigation pipe through the levee at approximately 18 feet below the crown. Wooden slide gates on the waterside (WS) end. Sliding metal gate noted in O&M manual. Concrete headwalls located on both WS and landside (LS). O&M manual structure reference is 4'-9" x 9'-6" concrete box culvert. (Automatic Board Order (ABO) issued as Permit No. 9482, 1974 - Elizabeth M. Farnsworth) [Additional Reference(s): DWR Levee Log, 1992. USACE Sacramento O&M Manual 137, August 1955, (Station 370+90)]. FS Date: 5/23/2017 10:14:12 AM

Overview of levee crown looking downstream at crossing.

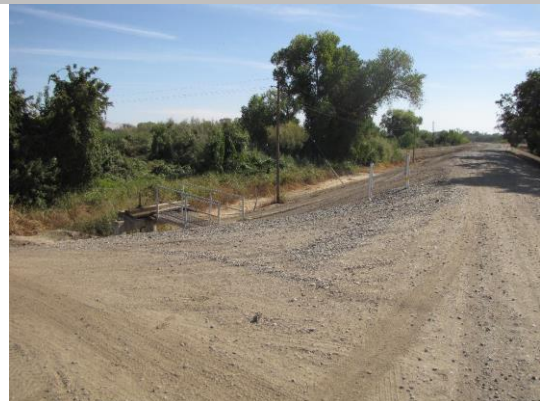
Photo 2 of 3 : UCIP_SP_2018_51875_70187.jpg

WS-walkway and concrete headwall.

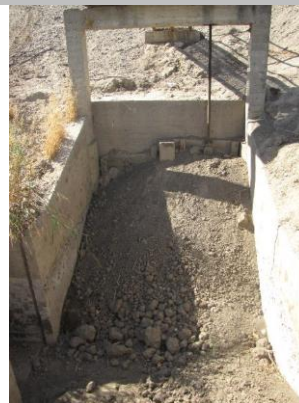
Photo 3 of 3 : UCIP_SP_2018_51875_70190.jpg

Comment Code						
Inspector Comment						
FS_ID:51875 DS_ID:16427 EP_NO: 9482 Repair Type: Non-Urgent Crossing Status: Found UCIP Comments: 5/3/2017 Abandoned- Needs to be done properly. (DWR Sutter Yard- A Freitag)10/24/2016 Abandoned.(DWR Sutter Yard- A Freitag)4/25/2016 Abandoned pipe. Needs to be properly plugged if it never gets used.4/20/2015 Same as last inspection. Structure is still buried.6/23/2014 Same as last inspection.12/17/2013 Same as last inspection.7/18/2013 Same as last inspection.10/19/2012 Structure is buried and non-operational. This crossing was listed in the USACE Periodic Inspection as ID# USACE_CESPK_MA1C_2010_p_0288 for sluice gate closed and backfilled on WS and full of sediment with wingwall cracked on LS. FIELD_STRUCT_DESC: *ABANDONED* 1 of 2: 36-inch reinforced concrete irrigation pipe through the levee at approximately 18 feet below the crown. Wooden slide gates on the waterside (WS) end. Sliding metal gate noted in O&M manual. Concrete headwalls located on both WS and landside (LS). O&M manual structure reference is 4'-9" x 9'-6" concrete box culvert. (Automatic Board Order (ABO) issued as Permit No. 9482, 1974 - Elizabeth M. Farnsworth) [Additional Reference(s): DWR Levee Log, 1992. USACE Sacramento O&M Manual 137, August 1955, (Station 370+90)]. FS Date: 5/23/2017 10:14:12 AM

View of crossing from WS side. WS blocked by sediment. 2 slide gates part of structure design.

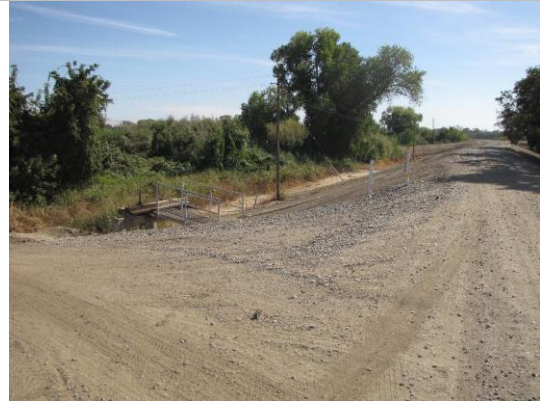
Photo 2 of 3 : UCIP_SP_2018_51876_70193.jpg

WS-walkway and concrete headwall.

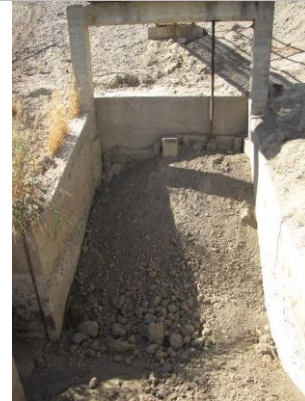
Photo 3 of 3 : UCIP_SP_2018_51876_70196.jpg

FS_ID:51876
DS_ID:17570
EP_NO: 9482
Repair Type: Non-Urgent
Crossing Status: Found
UCIP Comments: 5/3/2017 WS slide gate was unburied and crossing was being used for irrigation during site visit.(DWR Sutter Yard- AFreitag)10/24/2016 WS slide gate was unbruied and opened.(DWR Sutter Yard- AFreitag)4/25/2016 WS slide gate was unburied and opened allowing water to flow through to LS fields.4/20/2015 Structure is operational. WS slide gate was unburied allowing water to irrigate the fields. It gets reburied during highwater season.

View of crossing from WS. WS blocked by sediment. 2 slide gates part of structure design.

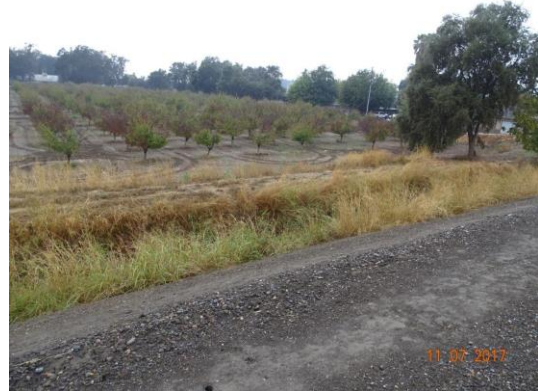
Photo 1 of 1 : SP_2018_MA0001_297_82_20180305_00018.jpg

LM Start	7.20	Rating **	U	Issue No.	82
LM End	7.26	Issue Type +	En	Location *	LS
Category	Earthen Levee			GPS Latitude/Longitude	
				Start	End
Item	Encroachments			39.293151 °	39.294042 °
				-122.021356 °	-122.021449 °
DWR ID	DWR_MA0001_01_s _ 2016_82				
Comment Code					
DT : Ditch					
Inspector Comment

View of the ditch along the landside toe.

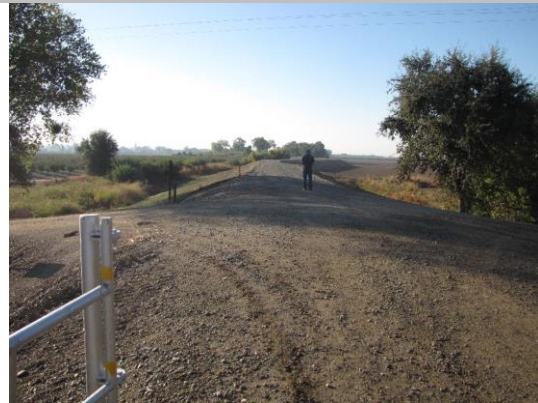
Photo 1 of 3 : UCIP_SP_2018_51877_70202.jpg

LM Start	7.27	Rating **	M	Issue No.	660	
LM End	7.27	Issue Type +	En	Location *		
Category	Supplemental			GPS Latitude/Longitude		
				Start	End	
Item	DWR UCIP Field Study			39.294074 °	39.294074 °	
				-122.021435 °	-122.021435 °	
DWR ID

Comment Code						
Inspector Comment						
FS_ID:51877 DS_ID:16456 EP_NO: N/A Repair Type: Non-Urgent Crossing Status: Found UCIP Comments: 5/3/2017 Culvert was flowing water during site visit. Appears to be in good condition. Some sediment build up in the bottom of WS box. (DWR Sutter Yard- AFreitag)10/24/2016 Notes mentioned needing to confirm size of the culvert but was unable to access the ends at this inspection.(DWR Sutter Yard- AFreitag)4/25/2016 Second slide gate was held open to allow water to flow through to the LS ditch.4/20/2015 Same as last inspection. Rebar pin was still in place holding the gate opened.6/23/2014 Same as last inspection.12/17/2013 Same as last inspection.7/18/2013 Same as last inspection.10/30/2012 Sediment and debris on waterward and landward side. This crossing was listed in the USACE Periodic Inspection as ID# USACE_CESPK_MA1C_2010_p_0293 for wooden slide gate held open by a piece of rebar acting as a pin. FIELD_STRUCT_DESC: 60-inches by 72-inches (5-foot by 6-foot) reinforced concrete box irrigation culvert (O&M manual references 3-foot and 10-inch by 6-foot culvert) through the levee, approximately 12-15 feet below the crown. Two wooden slide gates on the waterside (WS) end. Concrete v-ditch along landside (LS) toe. [Additional Reference(s): DWR Levee Log, 1992. USACE Sacramento O&M Manual 137, August 1955, (Station 385+33.5)]. FS Date: 5/23/2017 10:27:11 AM

Overview of levee crown looking downstream at crossing.

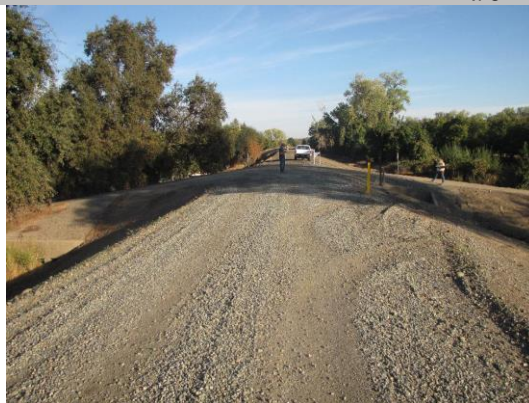
Photo 2 of 3 : UCIP_SP_2018_51877_70204.jpg

Overview of levee crown looking upstream at crossing.

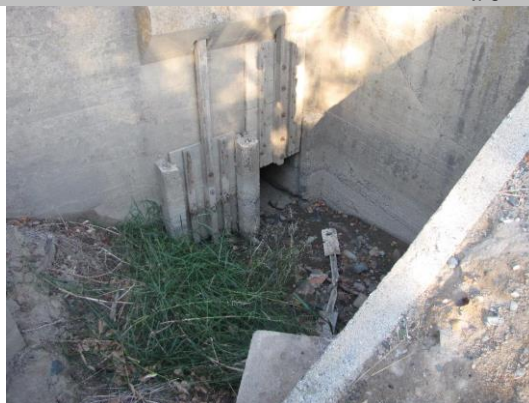
Photo 3 of 3 : UCIP_SP_2018_51877_70203.jpg

View of wooden sluice gates located on WS.

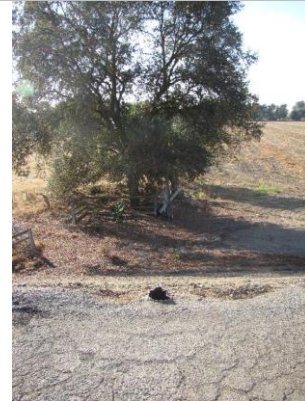
Photo 3 of 3 : UCIP_SP_2018_51878_70211.jpg

Comment Code						
Inspector Comment						
FS_ID:51878 DS_ID:16455 EP_NO: 12334 Repair Type: Non-Urgent Crossing Status: Found UCIP Comments: 5/3/2017 No LS inlet found and no pump on WS- appears to have been abandoned. If so needs to be done properly. (DWR Sutter Yard- A Freitag)10/24/2016 Pump removed from WS pipe. Pipe end left open and should be capped.(DWR Sutter Yard- A Freitag)4/25/2016 No LS inlet found4/20/2015 Same as last inspection.6/23/2014 Same as last inspection.12/17/2013 Same as last inspection.7/18/2013 Same as last inspection.10/30/2012 Siphon breaker housing unit is bent and has debris inside. LS outlet not found. FIELD_STRUCT_DESC: 10-inch asphalt coated steel irrigation pipe through the levee, 3 feet below the crown. Centrifugal pump on the waterside (WS) bank. Siphon breaker on the landside (LS) shoulder of the levee. (Permit No. 12334, 1978 - Jean James) [Additional Reference(s): DWR Levee Log, 1992]. FS Date: 5/23/2017 10:29:58 AM

View of LS with appurtenances present on levee shoulder.

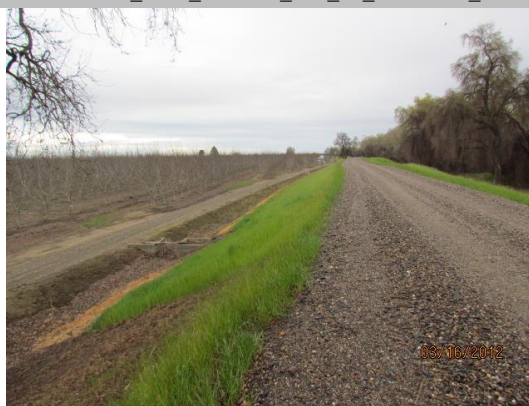
Photo 1 of 1 : SP_2018_MA0001_297_25_20180305_00011.jpg

LM Start	8.73	Rating **	M	Issue No.	25
LM End	9.19	Issue Type +	En	Location *	LS
Category	Earthen Levee			GPS Latitude/Longitude	
				Start	End
Item	Encroachments			39.308390 °	39.315125 °
				-122.031157 °	-122.030206 °
DWR ID	DWR_MA0001_01_s_2012_25				
Comment Code					
DT : Ditch					
Inspector Comment

View of the agricultural ditch along the L/S toe.

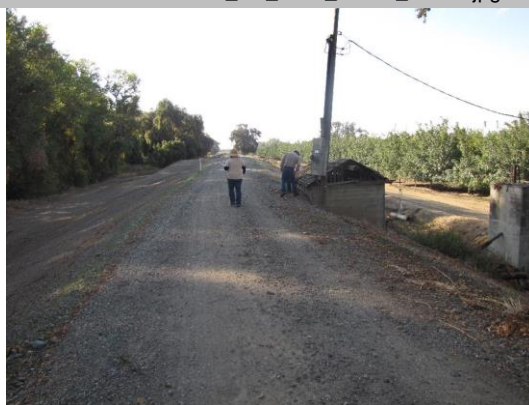
Photo 1 of 3 : UCIP_SP_2018_51879_70219.jpg

LM Start	8.92	Rating **	M	Issue No.	662
LM End	8.92	Issue Type +	En	Location *	
Category	Supplemental			GPS Latitude/Longitude	
				Start	End
Item	DWR UCIP Field Study			39.311103 °	39.311103 °
				-122.030541 °	-122.030541 °
DWR ID

Comment Code					
Inspector Comment					
FS_ID:51879 DS_ID:16454 EP_NO: 9466 Repair Type: Non-Urgent Crossing Status: Found UCIP Comments: 5/3/2017 Abandoned- needs to be done properly. (DWR Sutter Yard- A Freitag)10/24/2016 Abandoned.(DWR Sutter Yard- A Freitag)4/25/2016 Crossing appears to be abandoned. Power lines cut from the panels inside the concrete structure on LS.4/20/2015 Same as last inspection.6/23/2014 Same as last inspection.12/17/2013 Same as last inspection.7/18/2013 Same as last inspection.10/30/2012 No access to inspect slide gate on LS. Roof of pumping house deteriorating and debris scattered on LS. WS crossing not found. This crossing was listed in the USACE Periodic Inspection as ID# USACE_CESPK_MA1C_2010_p_345 no issues recorded. FIELD_STRUCT_DESC: *ABANDONED* 24-inch steel irrigation pipe through the levee, approximately 8-10 feet below the crown. Slide gate in concrete riser on the landside (LS) slope. Pump house encroaches into the LS slope. Two service poles on the LS shoulder. No visible appurtenances found on the waterside (WS) toe. Power source cut on the LS. (Automatic Board Order (ABO) issued as Permit No. 9466, 1974 - Roman Catholic Bishop of Sacramento). [Additional Reference(s): DWR Levee Log, 1992]. FS Date: 5/23/2017 10:31:07 AM

Overview of levee crown looking downstream at crossing.

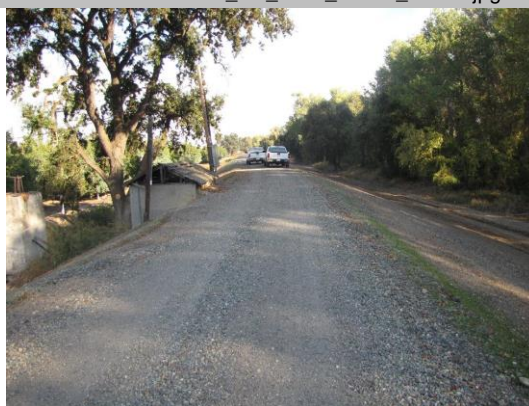
Photo 2 of 3 : UCIP_SP_2018_51879_70217.jpg

Overview of levee crown looking upstream at crossing.

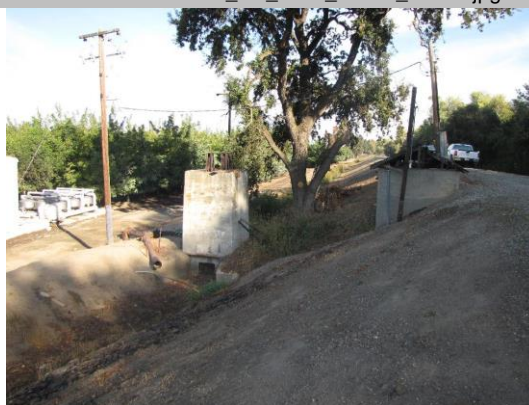
Photo 3 of 3 : UCIP_SP_2018_51879_70218.jpg

View of pump and standpipe located on LS.

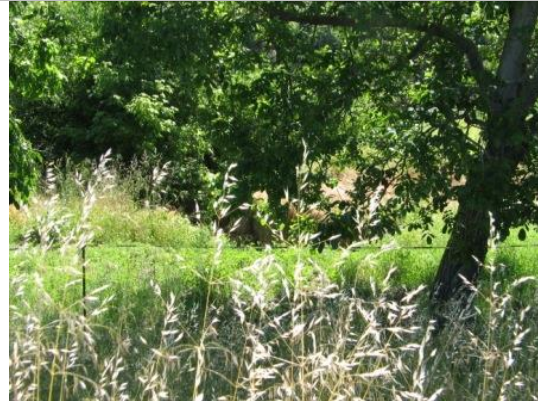
Photo 1 of 1 : SP_2018_MA0001_297_18_20180305_00009.jpg

LM Start	10.13	Rating **	M	Issue No.	18
LM End	10.13	Issue Type +	Ma	Location *	WS
Category	Earthen Levee			GPS Latitude/Longitude	
				Start	End
Item	Erosion / Bank Caving			39.328697 °	39.328697 °
				-122.029262 °	-122.029262 °
DWR ID	DWR_MA0001_01_s_2012_18				
Comment Code					
E1 : Note and monitor erosion site.					
Inspector Comment					
Monitor the erosion site.

View of the erosion along the waterside of the levee.

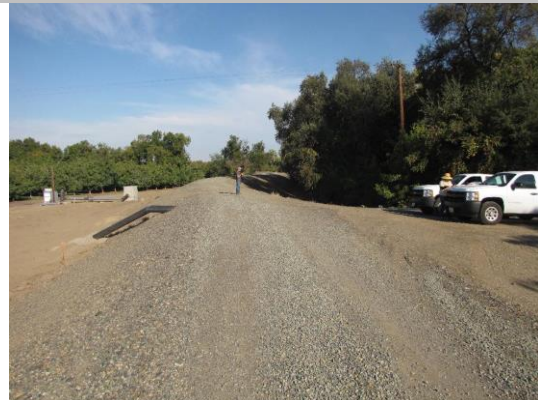
Photo 1 of 3 : UCIP_SP_2018_51883_70236.jpg

LM Start	10.21	Rating **	U	Issue No.	665	
LM End	10.21	Issue Type +	En	Location *		
Category	Supplemental			GPS Latitude/Longitude		
				Start	End	
Item	DWR UCIP Field Study			39.329750 °	39.329750 °	
				-122.029602 °	-122.029602 °	
DWR ID

Comment Code						
Inspector Comment						
FS_ID:51883 DS_ID:16452 EP_NO: 1800 Repair Type: Urgent Crossing Status: Found UCIP Comments: 5/3/2017 Rain run off erosion still present near pipe on WS sshoulder. (DWR Sutter Yard- AFreitag)10/24/2016 Ws erosion still present. Looks to be just from rain run off.(DWR Sutter Yard- AFreitag)4/25/2016 Erosion still present by the WS pipes. (DWR Sutter Yard - afreitag)4/20/2015 Erosion happening near WS shoulder where the pipes enter the levee. May just be caused by rain runoff. (DWR Sutter Yard - afreitag)6/23/2014 Same as last inspection. (DWR Sutter Yard - afreitag)12/17/2013 Same as last inspection. (DWR Sutter Yard - afreitag)7/18/2013 Same as last inspection. (DWR Sutter Yard - afreitag)10/30/2012 This crossing has been completely modified--need recent permit issued to allow work on levee and levee toe. Was levee compacted to CVFPB standards? This crossing was listed in the USACE Periodic Inspection as ID# USACE_CESPK_MA1C_2010_p_0371 unable to determine why this crossing was assigned "U". (DWR UCIP - omagana) FIELD_STRUCT_DESC: 1 of 2: 14-inch steel irrigation pipe through the levee, approximately 3-4 feet below the crown. Siphon breakers on the waterside (WS) end. (Permit No. 1800, 1959 - Jimeno Rancho) New pipe visible on the landside (LS). [Additional Reference(s): DWR Levee Log, 1992]. FS Date: 5/23/2017 10:36:55 AM

Overview of levee crown looking upstream at crossing.

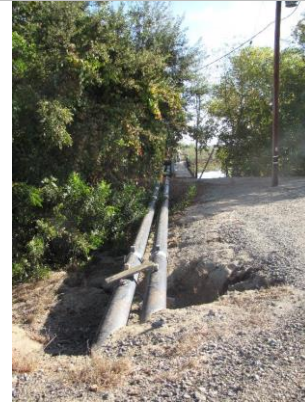
Photo 2 of 3 : UCIP_SP_2018_51883_70235.jpg

View of 2-14 inch crossings through levee on WS.

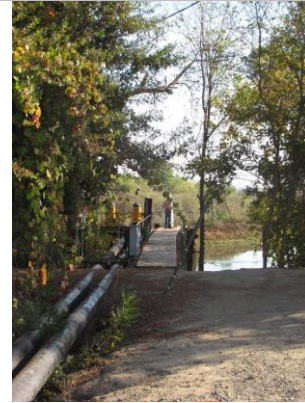
Photo 3 of 3 : UCIP_SP_2018_51884_70226.jpg

Item	DWR UCIP Field Study			39.329750 °	39.329750 °	
				-122.029602 °	-122.029602 °	
DWR ID						
Comment Code						
Inspector Comment						
FS_ID:51884 DS_ID:17571 EP_NO: 1800 Repair Type: Urgent Crossing Status: Found UCIP Comments: 5/3/2017 Rain runoff erosion still present near pipes on WS shoulder. (DWR Sutter Yard- AFreitag)10/24/2016 Ws erosion still present. Looks to be just from rain run off.(DWR Sutter Yard- AFreitag)4/25/2016 Erosion still present near the WS pipes. (DWR Sutter Yard - afreitag)4/20/2015 Erosion happening on WS shoulder near where pipes enter the levee. May just be from rain runoff. (DWR Sutter Yard - afreitag)6/23/2014 Same as last inspection. (DWR Sutter Yard - afreitag)12/17/2013 Same as last inspection. (DWR Sutter Yard - afreitag)7/18/2013 Same as last inspection. (DWR Sutter Yard - afreitag)10/30/2012 This crossing has been completely modified--need recent permit issued to allow work on levee and levee toe. Was levee compacted to CVFPB standards? This crossing was listed in the USACE Periodic Inspection as ID# USACE_CESPK_MA1C_2010_p_0371 unable to determine why this crossing was assigned "U". (DWR UCIP - omagana) FIELD_STRUCT_DESC: 2 of 2: 14-inch steel irrigation pipe through the levee, approximately 3-4 feet below the crown. Siphon breaker located on the waterside (WS) end. (Permit No. 1800, 1959 - Jimeno Rancho) [Additional Reference(s): DWR Levee Log, 1992]. FS Date: 5/23/2017 10:37:52 AM

View of catwalk and pump station located on WS.

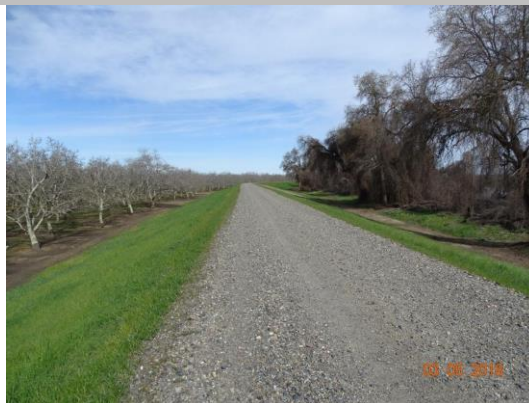
Photo 1 of 1 : SP_2018_MA0001_297_68_20180312_00150.jpg

LM Start	10.52	Rating **	A	Issue No.	68
LM End	10.52	Issue Type +	Ma	Location *	LS
Category	Earthen Levee			GPS Latitude/Longitude	
				Start	End
Item	Vegetation			39.333925 °	39.333925 °
				-122.031355 °	-122.031355 °
DWR ID	DWR_MA0001_01_s_2018_68				
Comment Code					
V1 : Control annual grass and weeds on the levee slopes and easements.					
Inspector Comment					
There is native grasses on both slopes.

View of native grasses on both slopes.

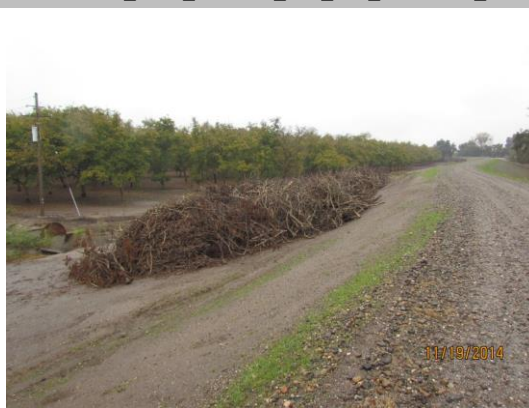
Photo 1 of 1 : SP_2018_MA0001_297_637_20180305_00043.jpg

LM Start	10.78	Rating **	M	Issue No.	637
LM End	10.78	Issue Type +	En	Location *	LS
Category	Earthen Levee			GPS Latitude/Longitude	
				Start	End
Item	Encroachments			39.337523 °	39.337523 °
				-122.032437 °	-122.032437 °
DWR ID	DWR_MA0001_01_f_2014_637				
Comment Code					
PR : Prunings					
Inspector Comment

View of the pruning along the landside toe.
